Condition Assessment

Great Lakes Navigation Structures Condition Assessment

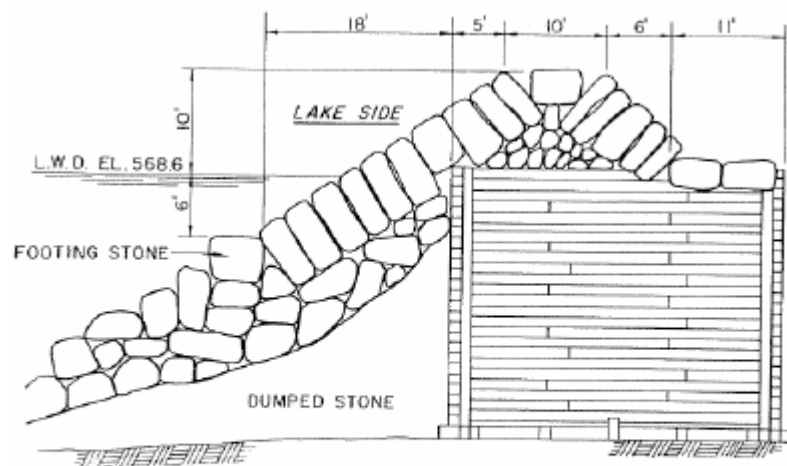
Cleveland Harbor, Ohio – Structure Cross Sections

SECTION "Y"
EAST BREAKWATER
(BUILT 1887-1900)
(STONE SUPERSTRUCTURE BUILT 1917-1926)

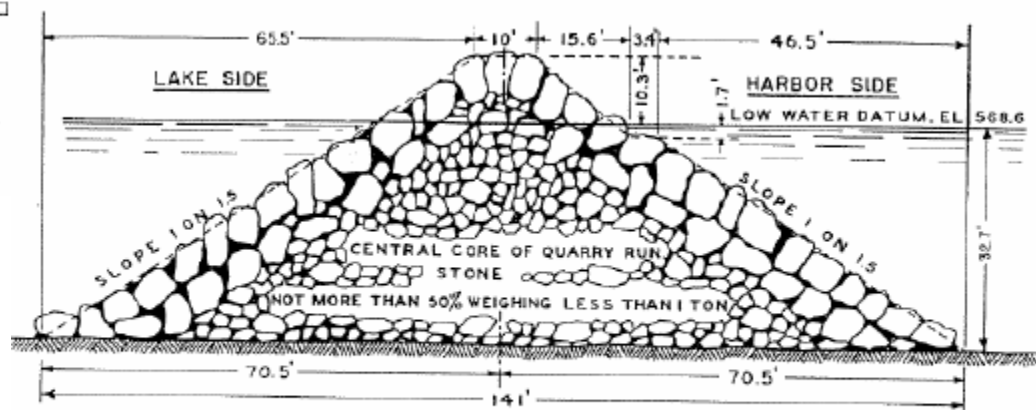
SECTION OF EAST BREAKWATER -P-
(BUILT 1903-1915)
